Annex 1
Photographic documentation
Tests for the pendulum impact tests on ESG glass panes backed with PVC foil

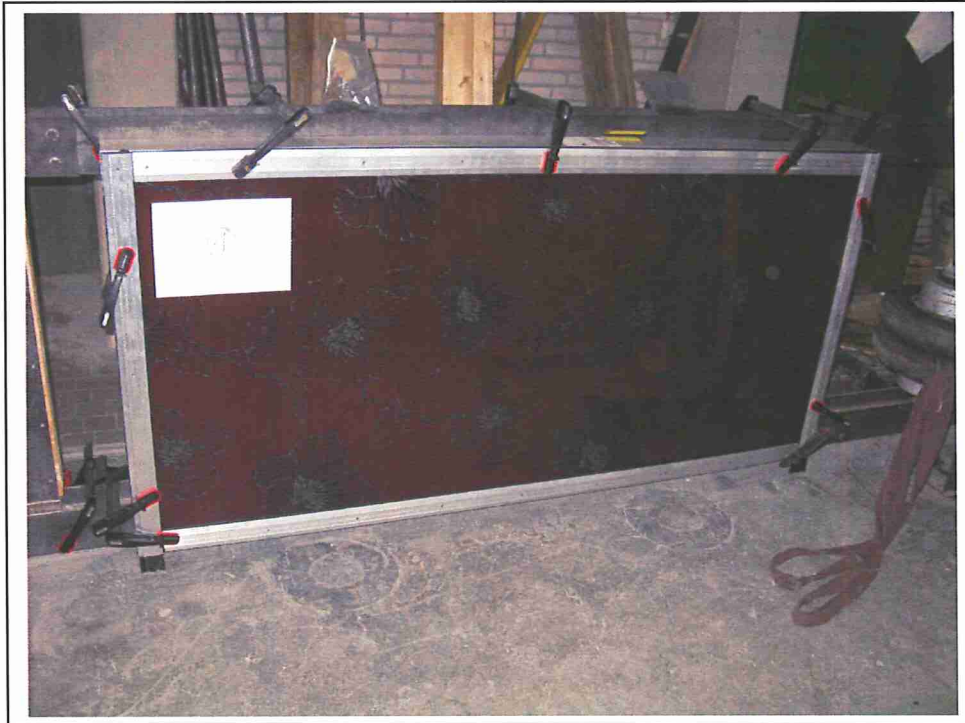
Fig. 1 Test frame / glass pane 1

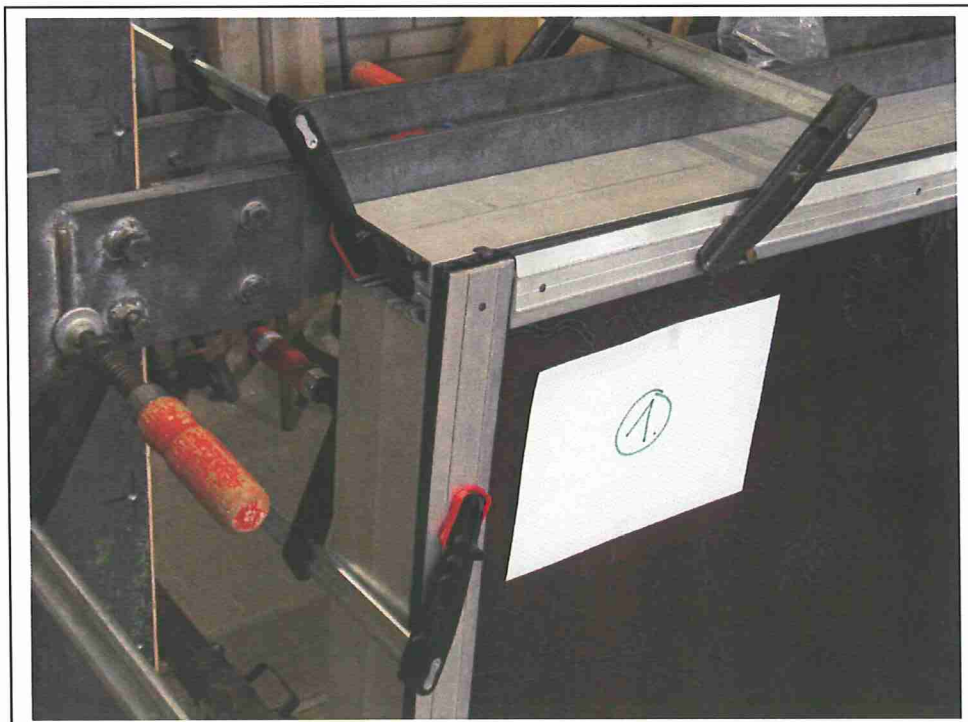
Fig. 2 Corner of the test frame

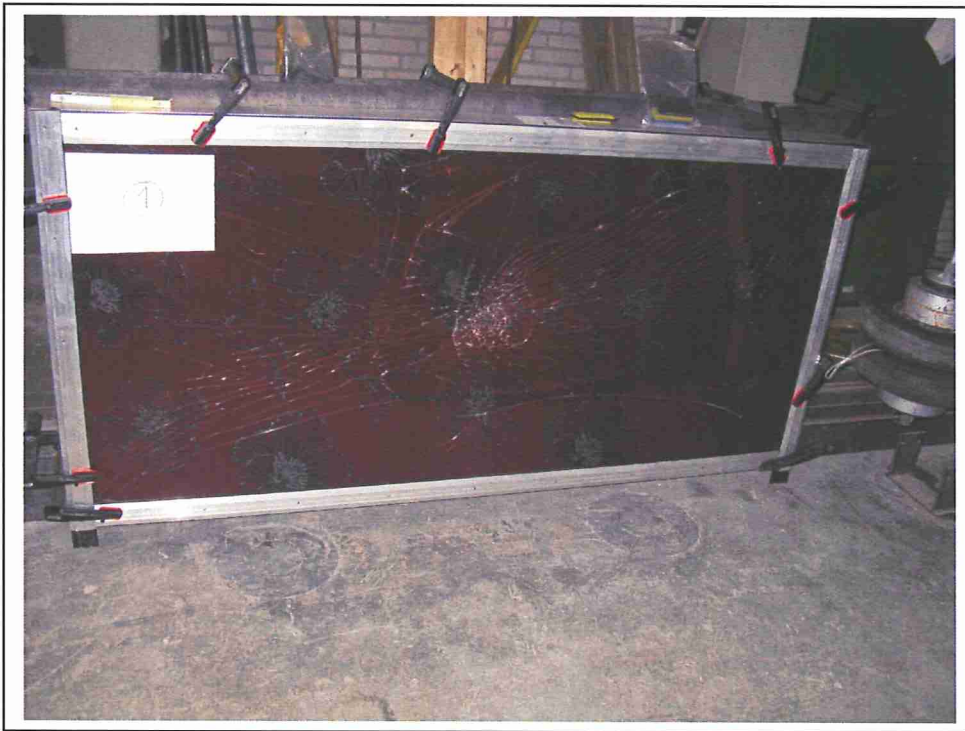
Fig. 3 Test: glass pane 1, 450 mm

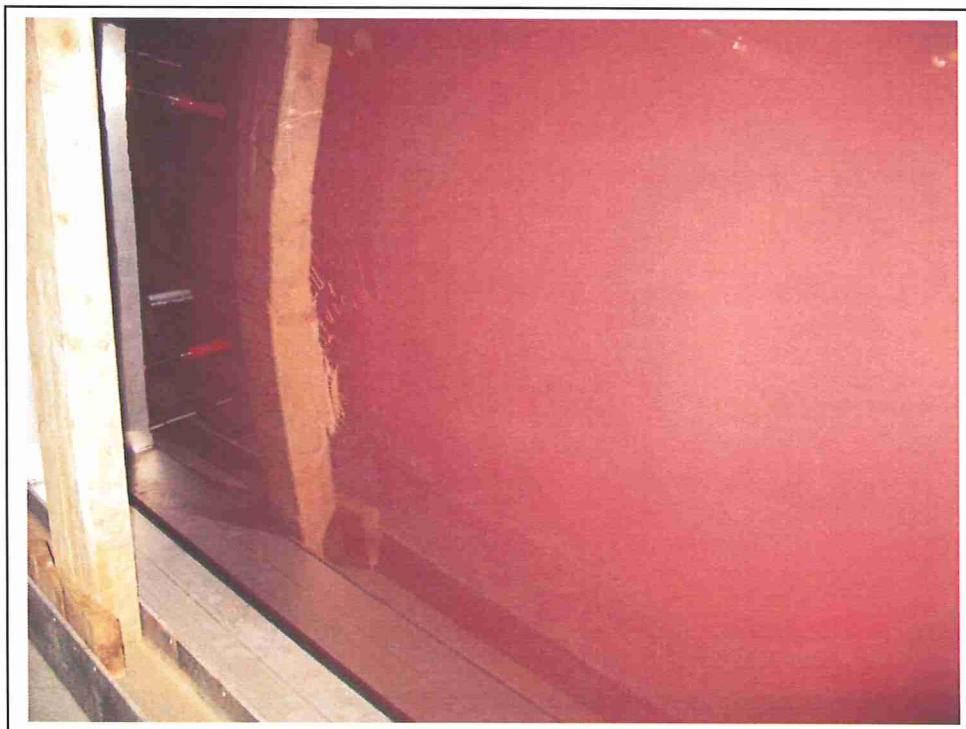
Fig. 4 Back of the glass pane

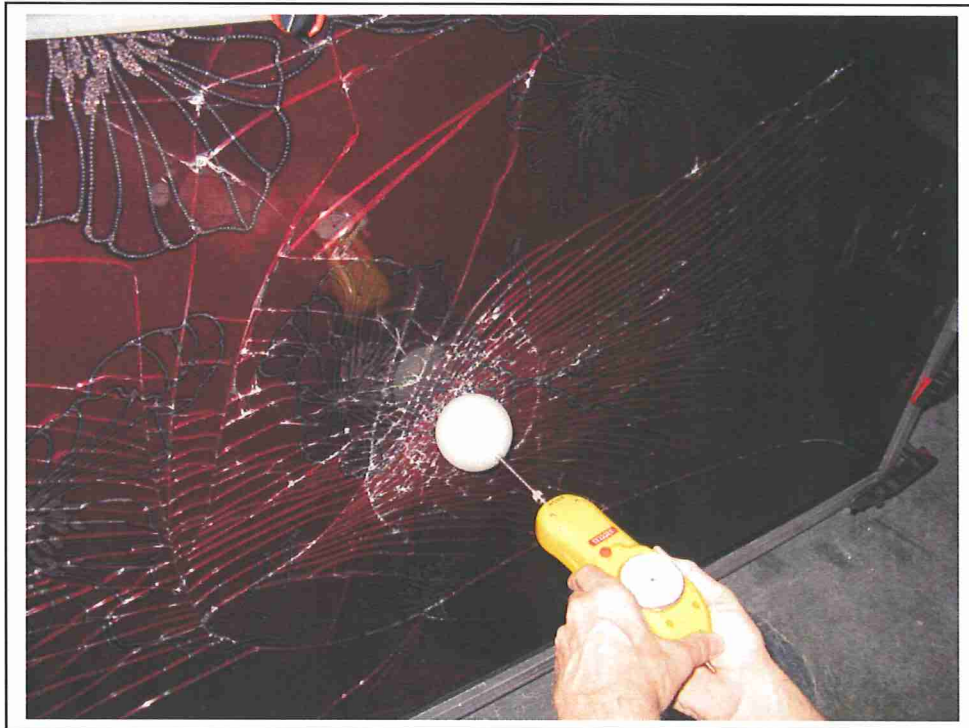
Fig. 5 Test using the ball \varnothing 76 mm

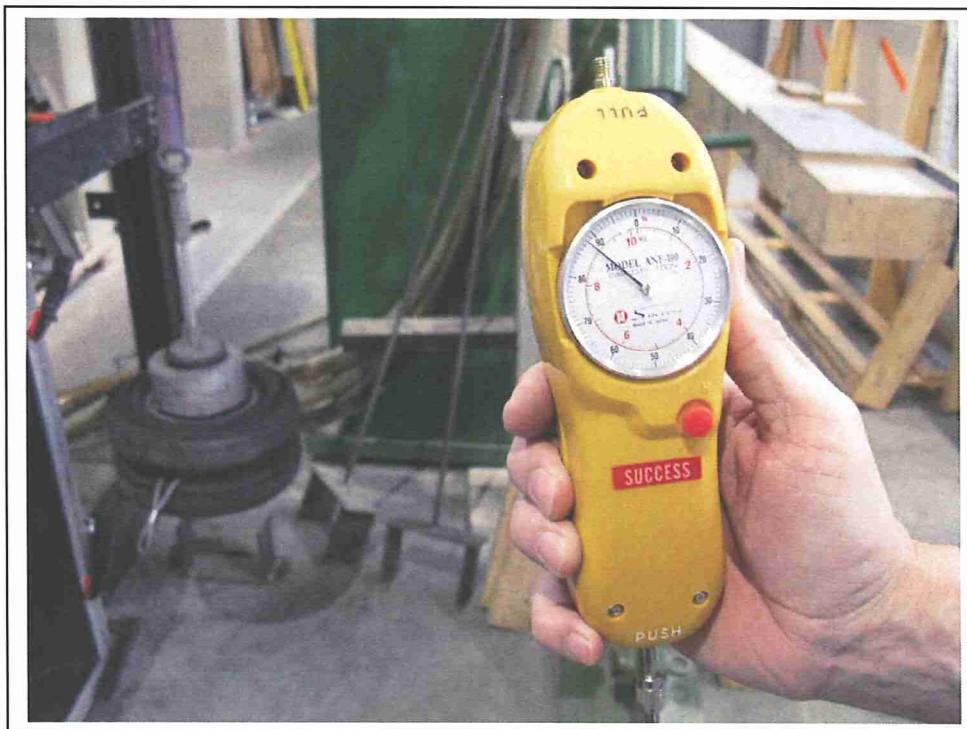
Fig. 6 max. test force 88 N

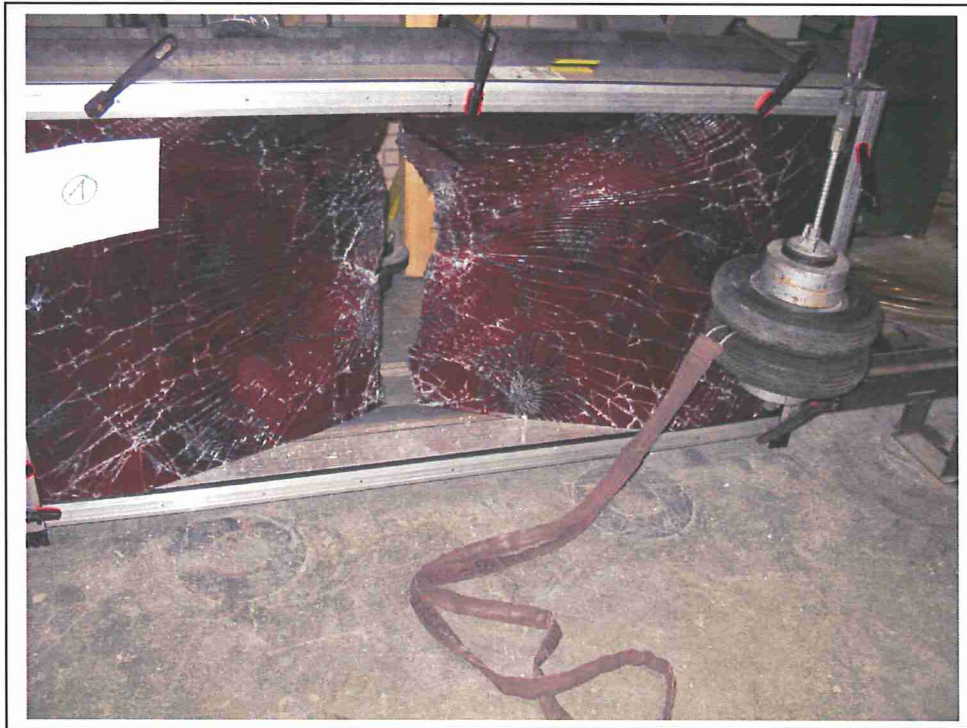
Fig. 7 Test / glass pane 1 / 900 mm

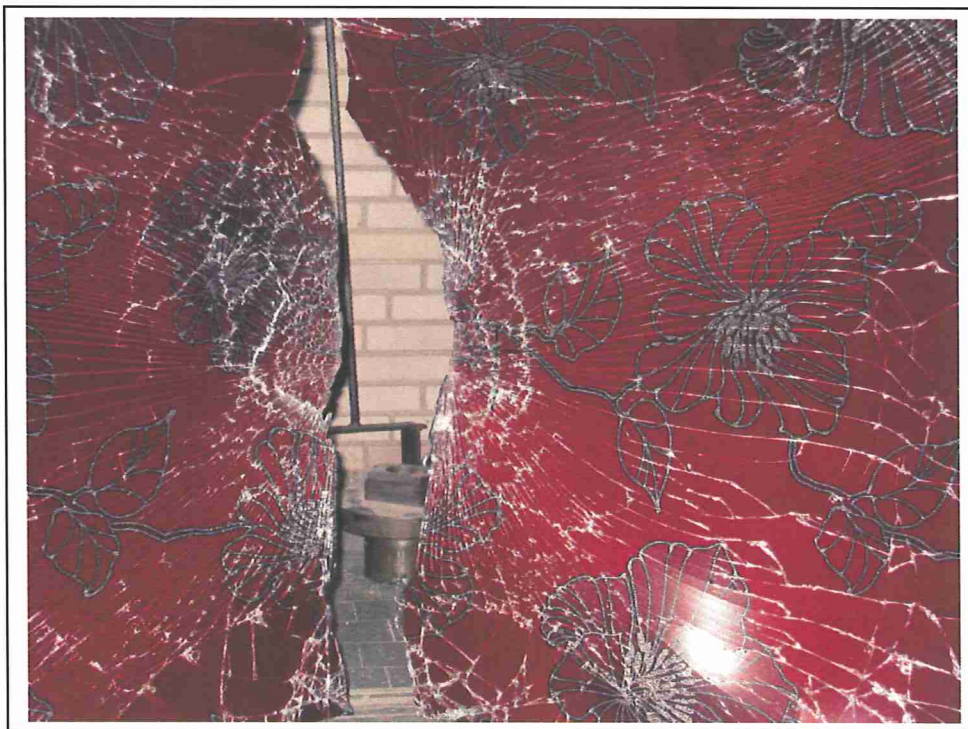
Fig. 8 Detail of the fracture

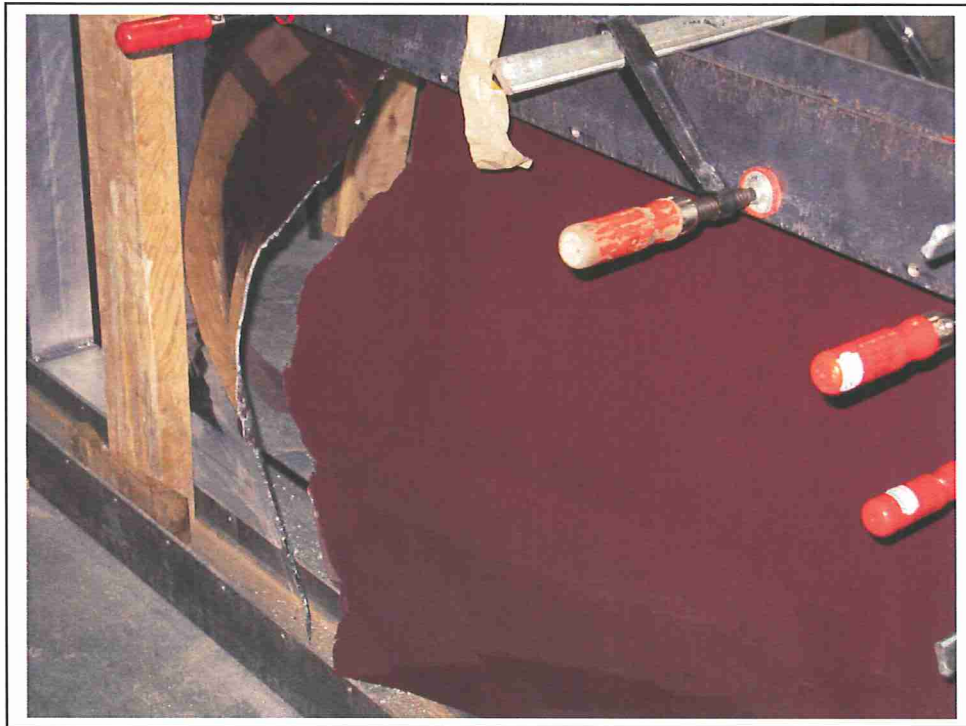
Fig. 9 Back

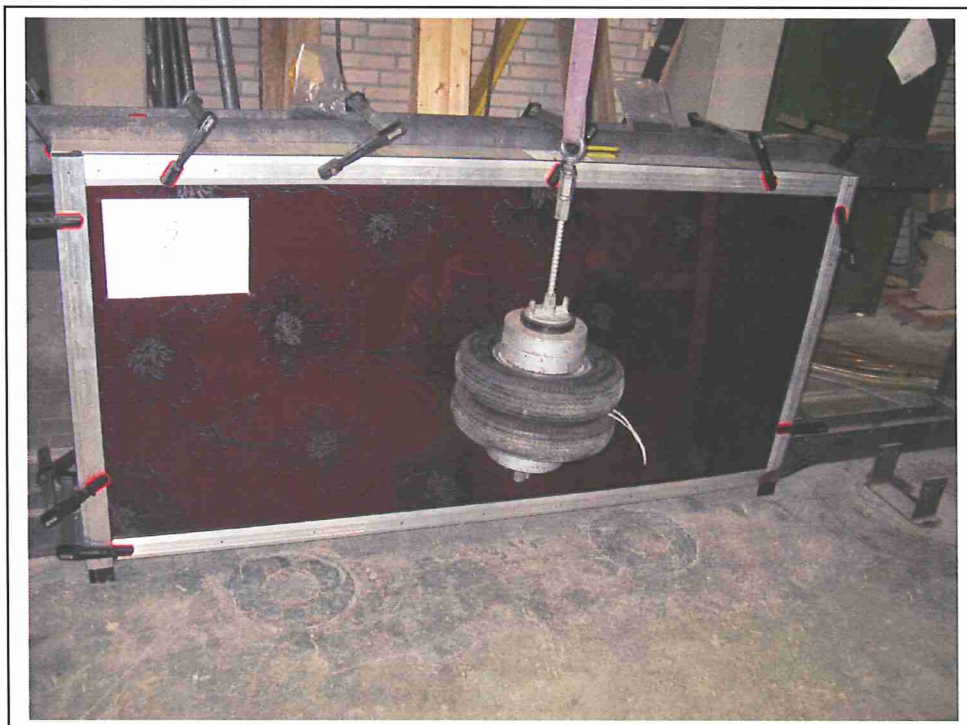
Fig. 10 Test / glass pane 2

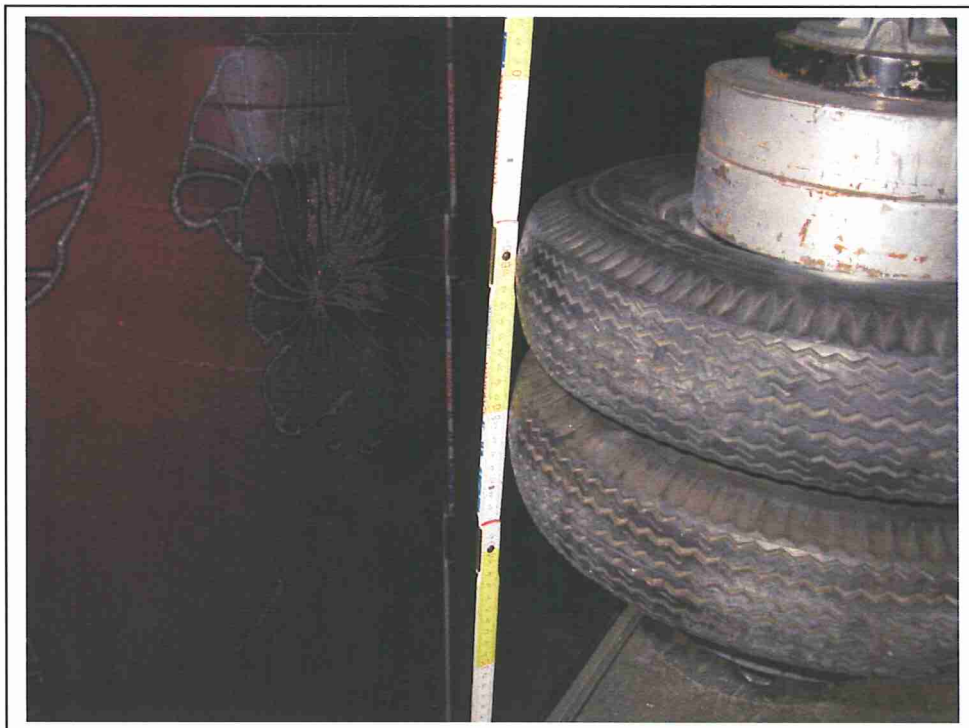
Fig. 11 glass pane 2, as Fig. 10

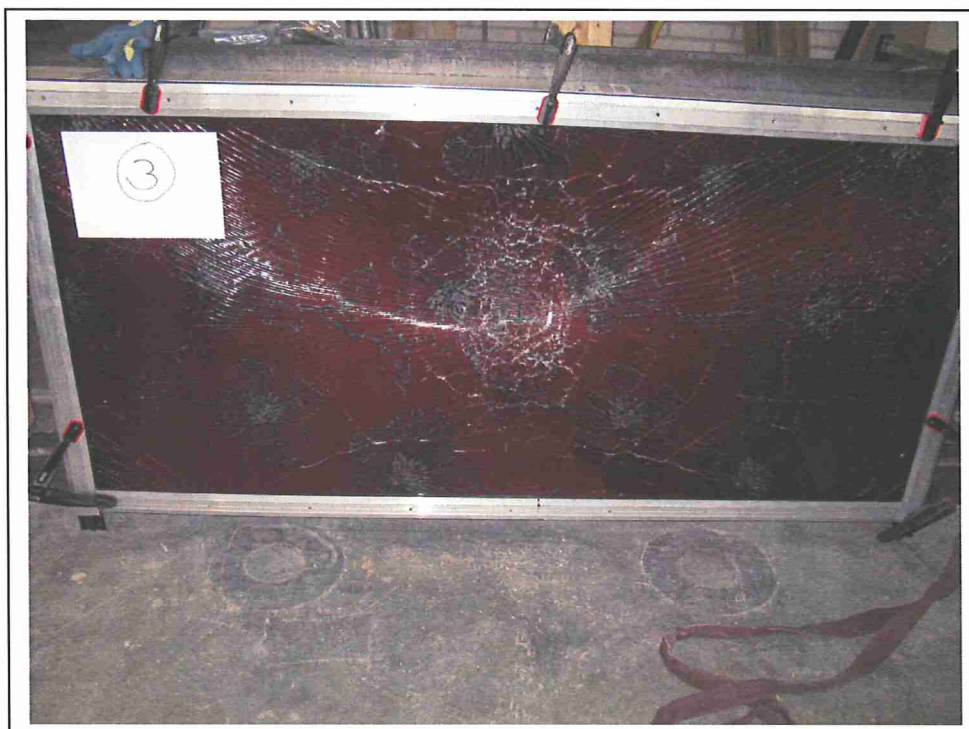
Fig. 12 Test / glass pane 3

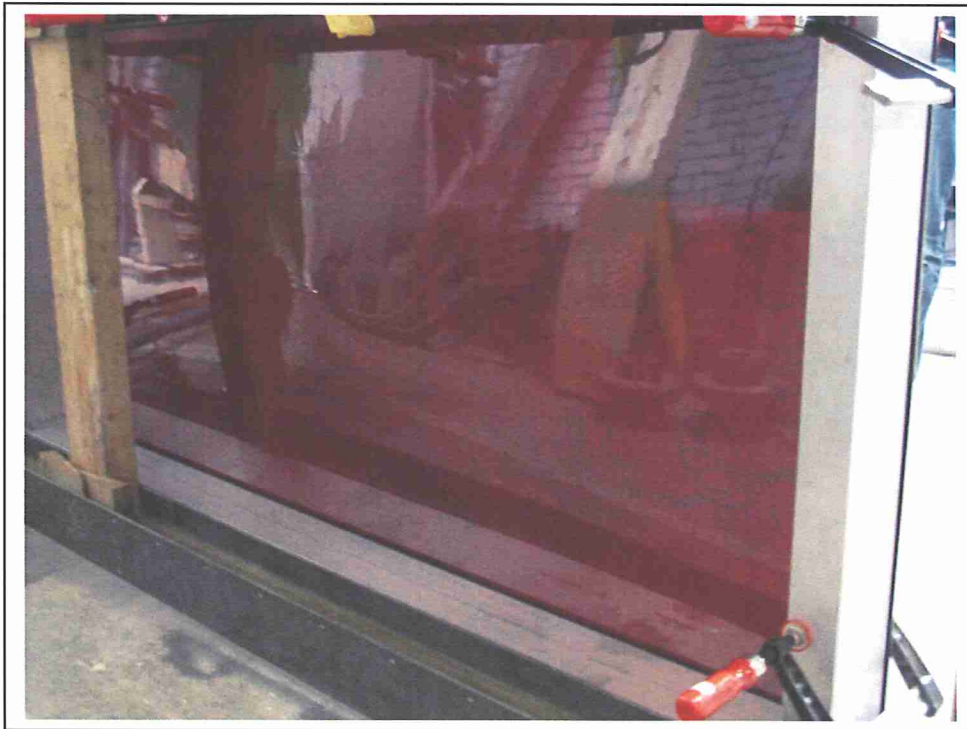
Fig 13 Back / of glass pane 3

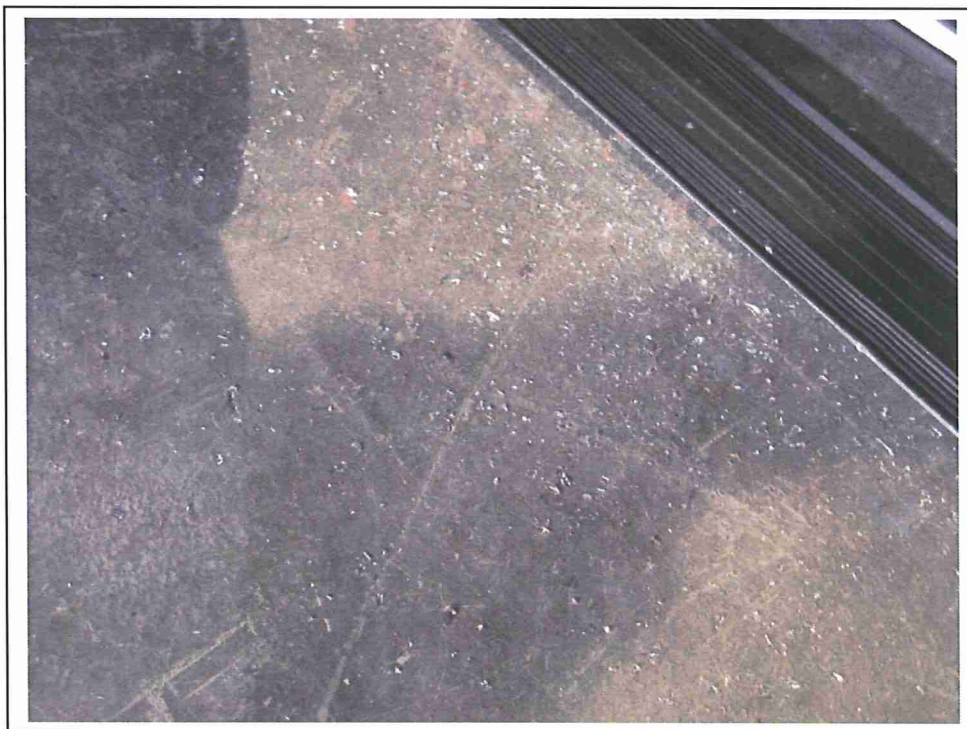
Fig. 14 Glass splinters

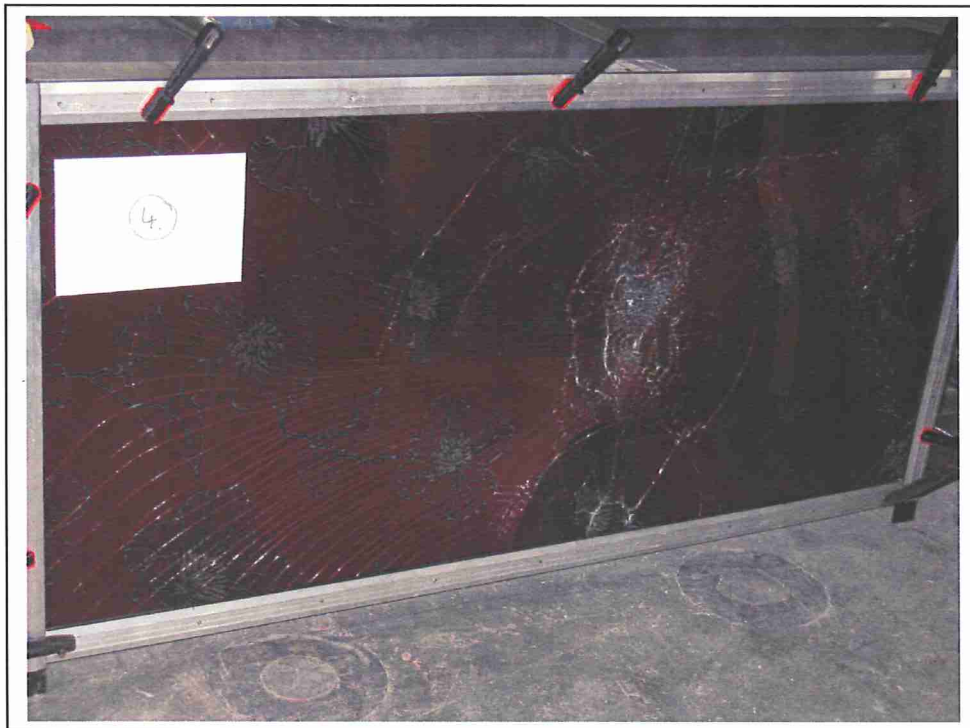
Fig. 15 Test / glass pane 4

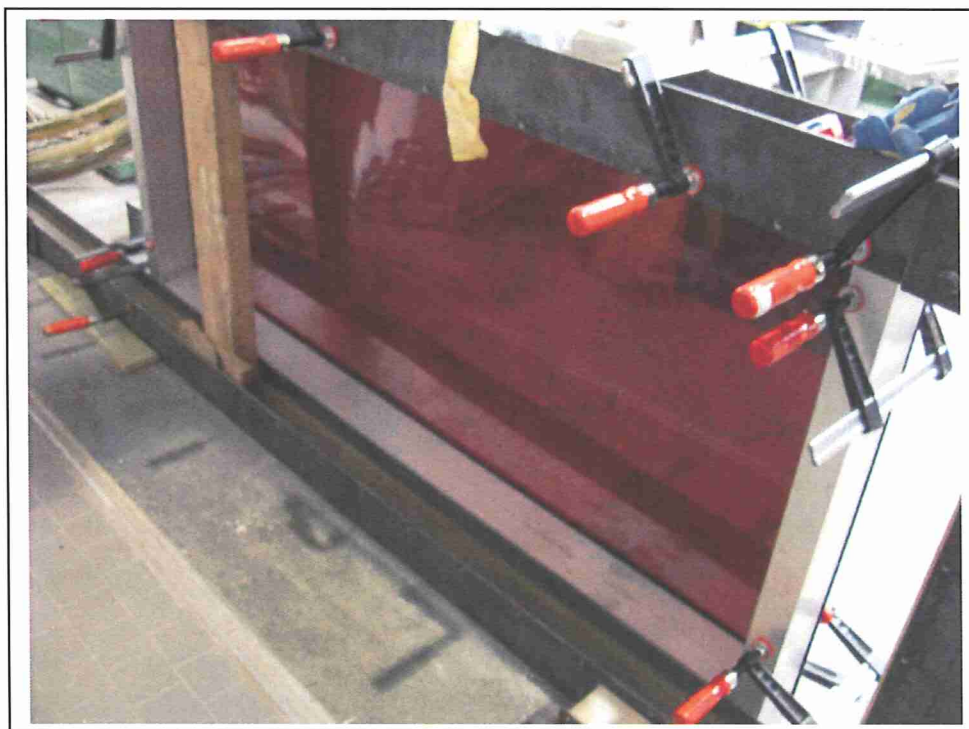
Fig. 16 Back / glass pane 4

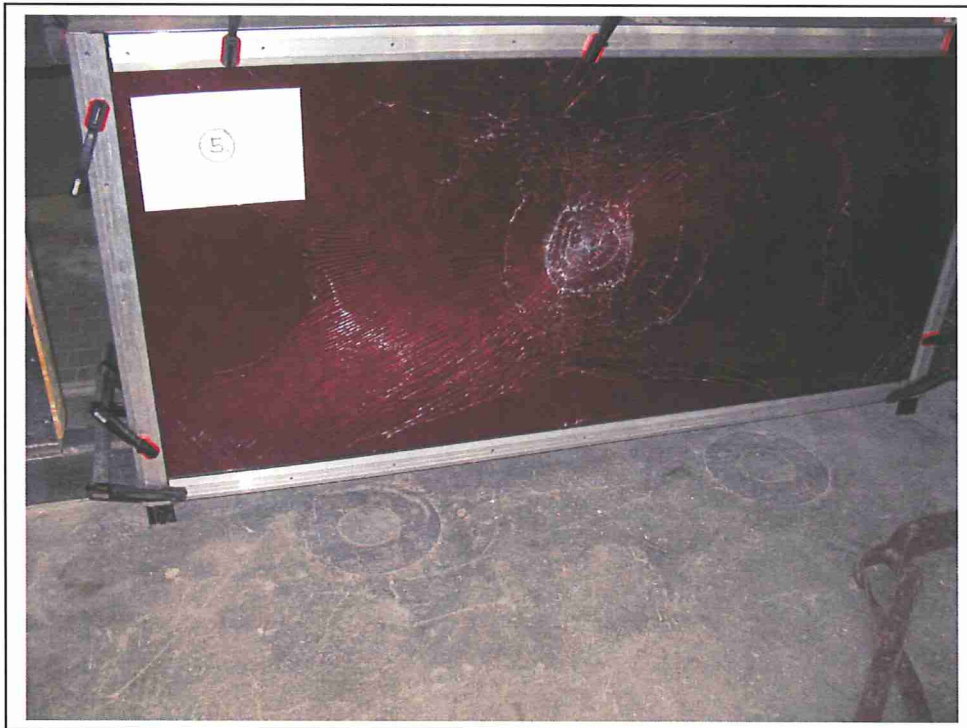
Fig. 17 Test / glass pane 5

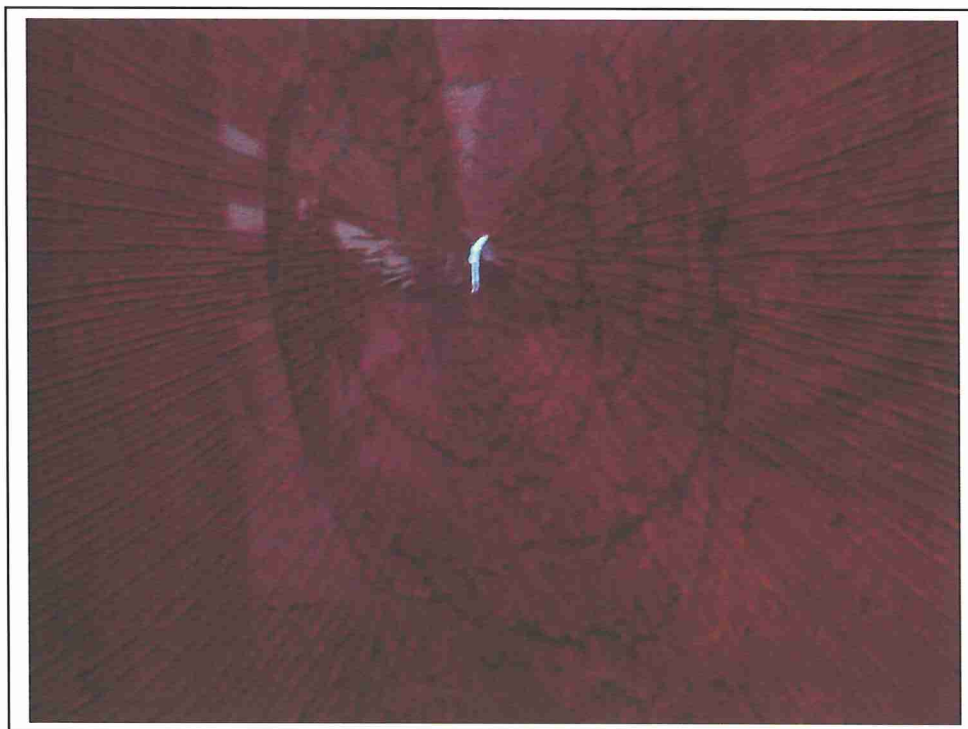
Fig. 18 Back of the glass pane 5

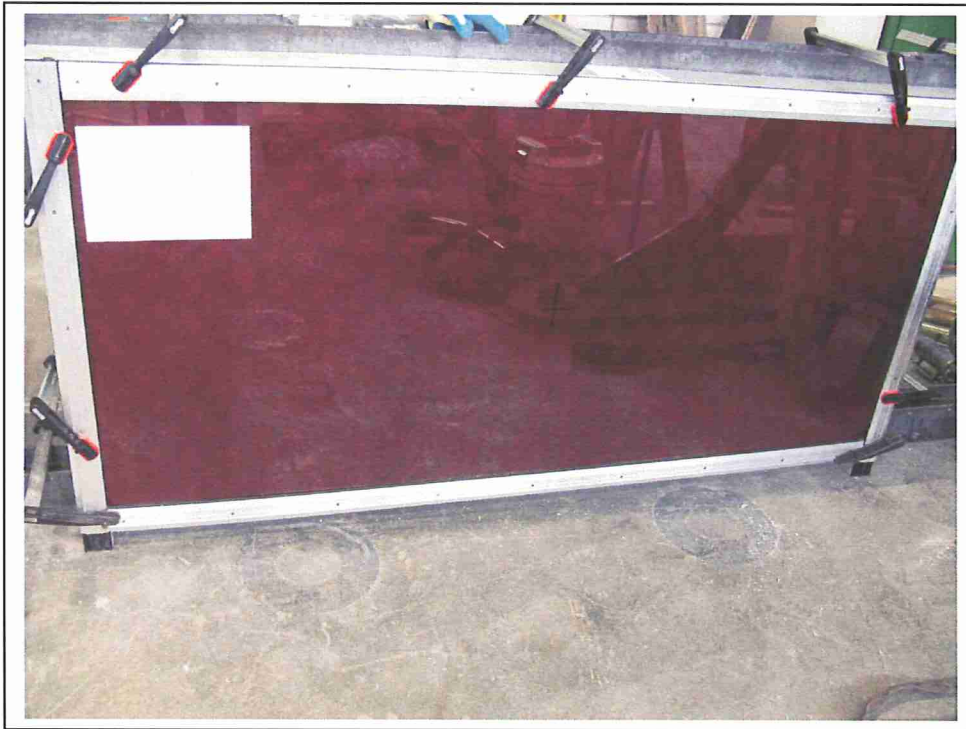
Fig. 19 Glass pane 6 prior to the impact test

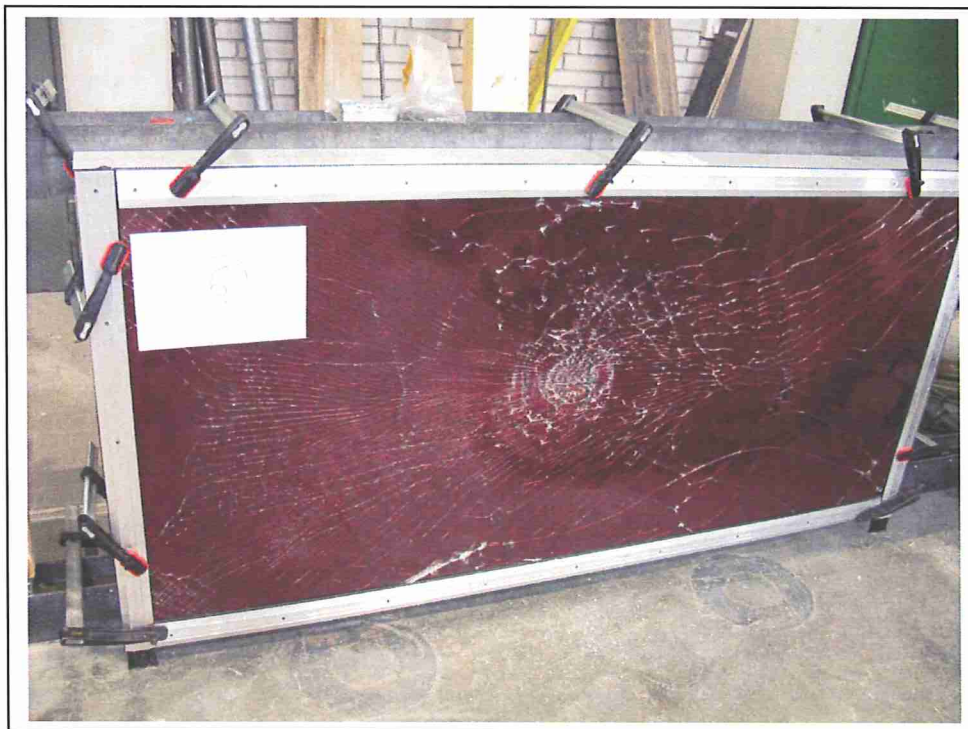
Fig 20 after the impact

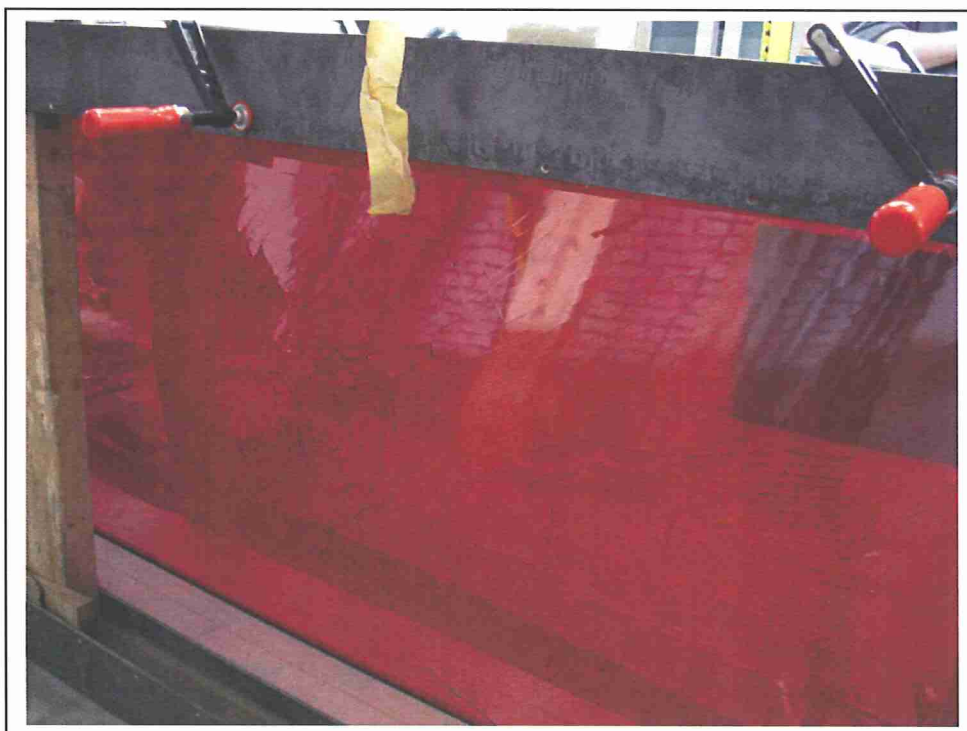
Fig. 21 Back

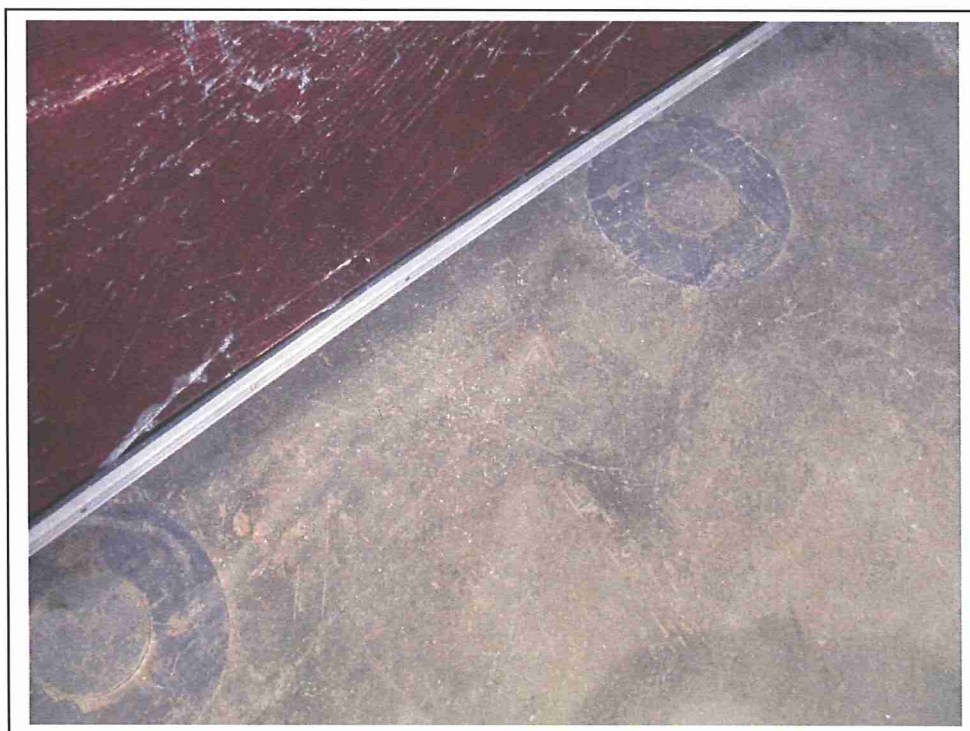
Fig. 22 Lower edge

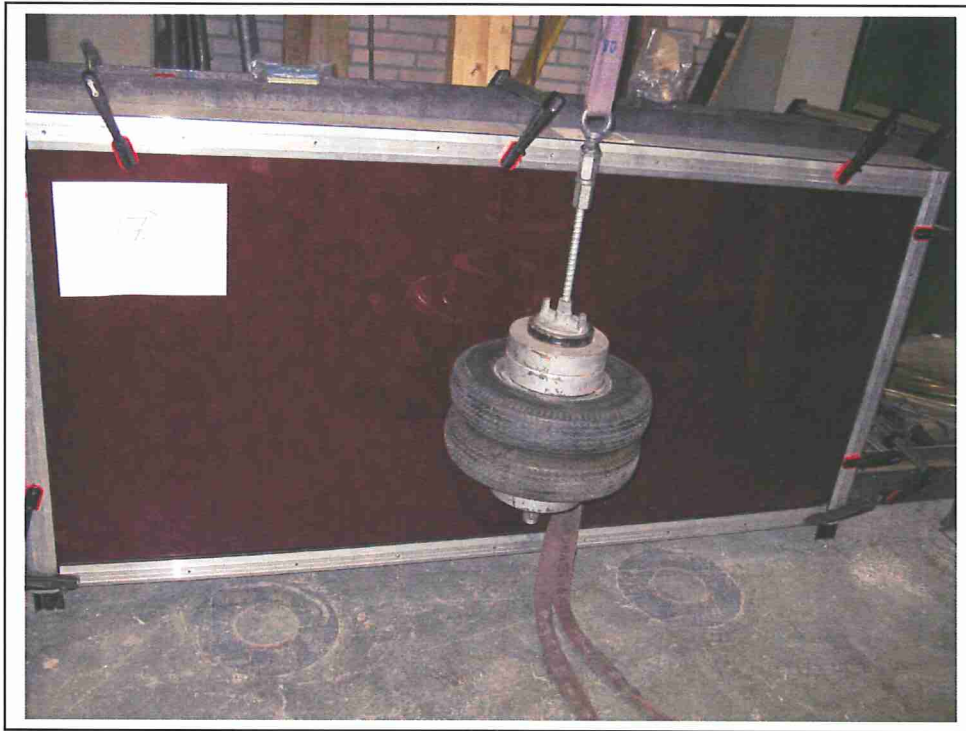
Fig. 23 Test / glass pane 7

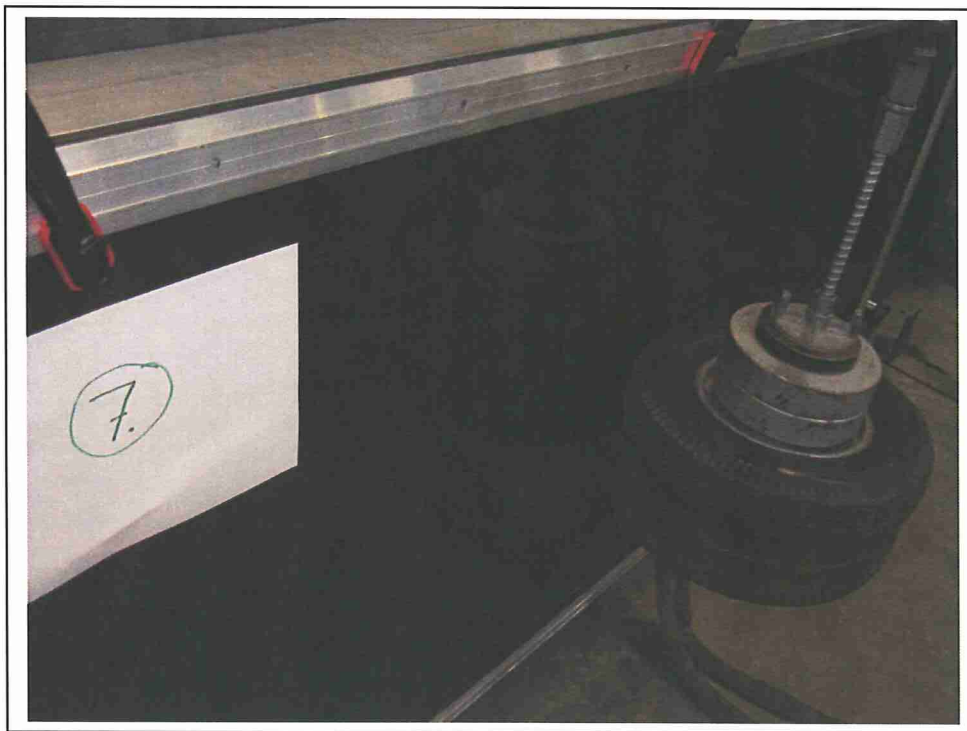
Fig. 24 Test / glass pane 7

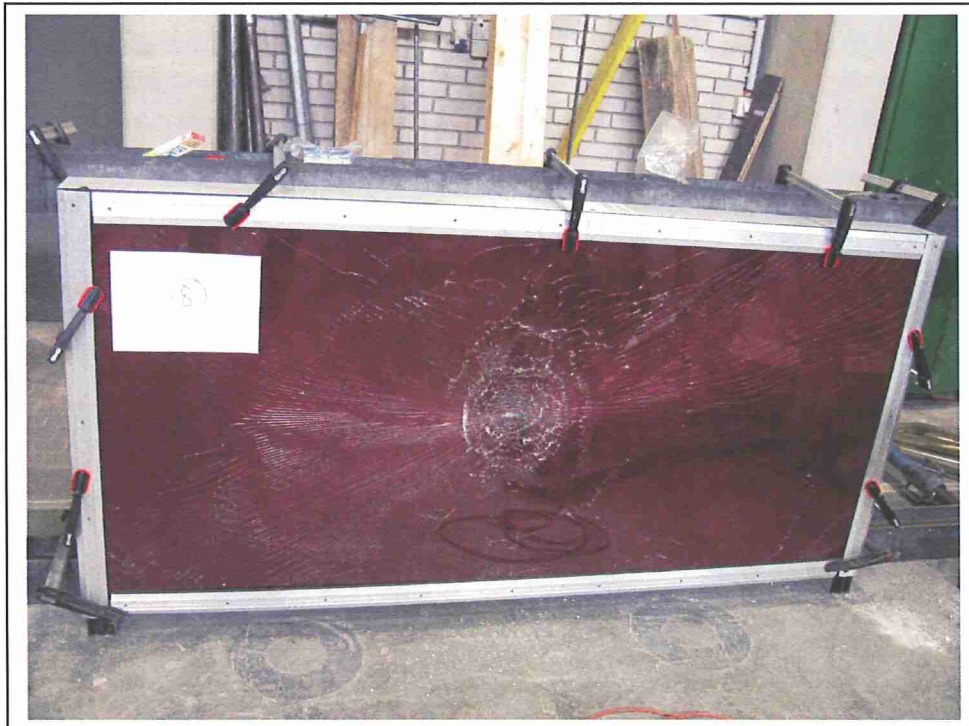
Fig. 25 Test / glass pane 8

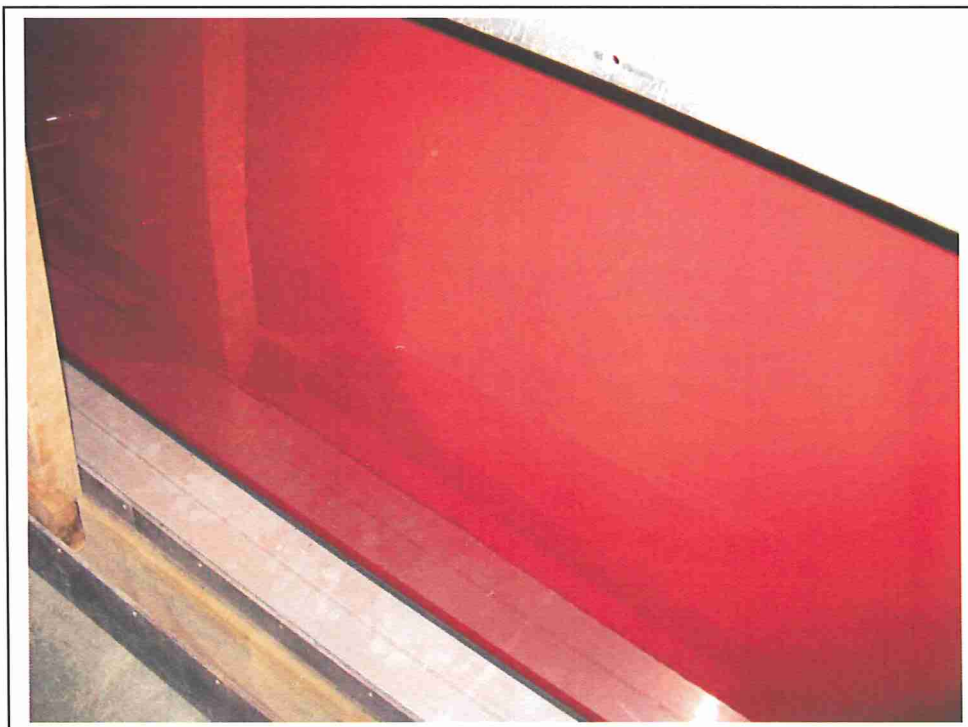
Fig. 26 Back, glass pane 8

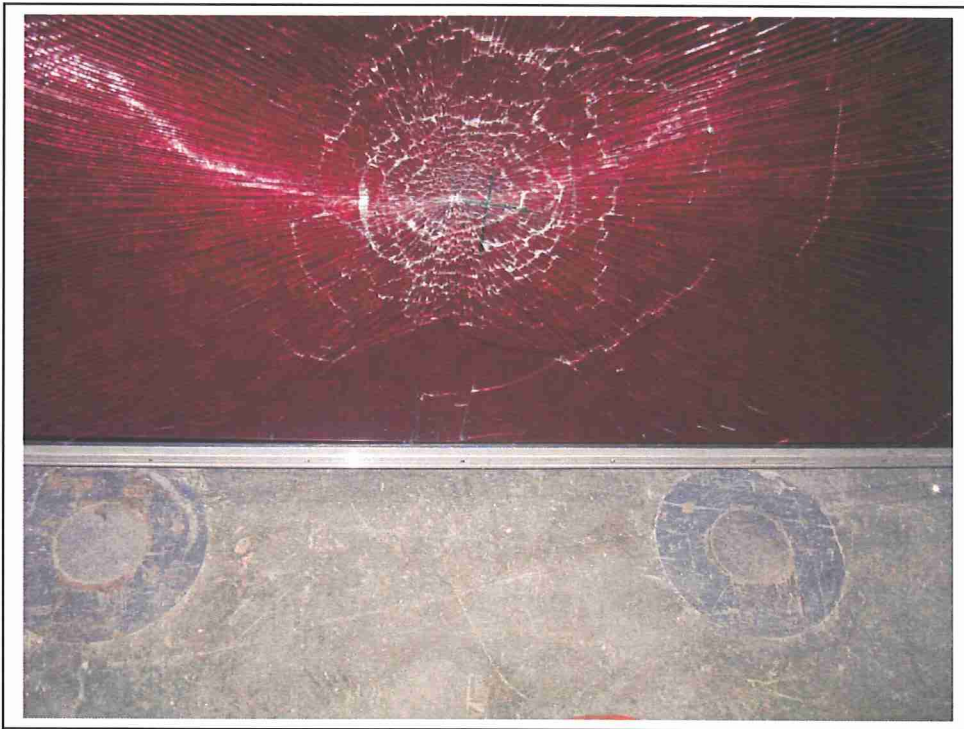
Fig. 27 Glass pane 8, lower edge
